Manhole Inspection Summary

Manhole # S31E__020MH

Insp Date: **12/16/08 10:27 AM**

Location Address: **128 W Lexington St**

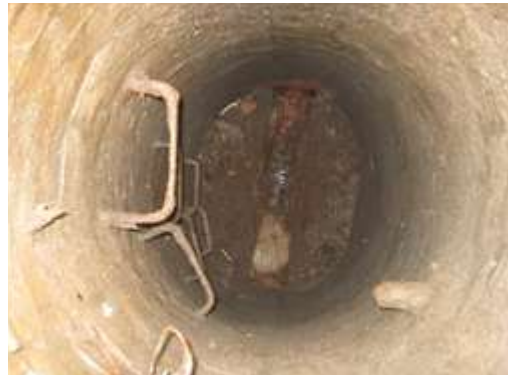
Top View

Comments **do to the walls covered with wet mud unable to identify if corbel or barrel has any true defects.**

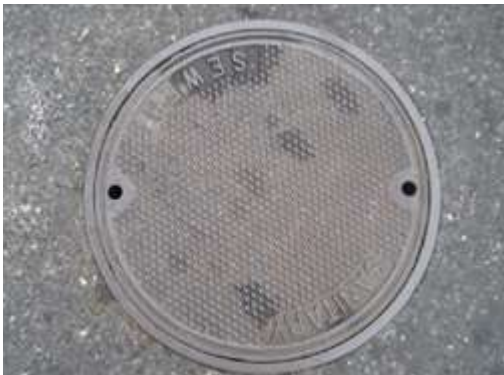
Frame Offset: **0** (in.) Condition: ☐ Sound ☐ Cracked ☒ **Leaks**

cover pic

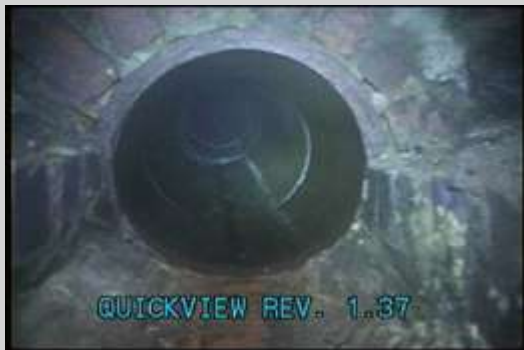
12 O'Clock Outflow

10 in. Circular Gravity Sewer
Pipe Out @ 12 O'Clock

Pipe Height: **10.8** (in.) Rod and Bar (Angled)
Pipe Material: **Clay** ☐ Pipe Lined
Invert Depth: **11.41** (ft.) Flow Characteristics: **None**
Deposits: ☒ None ☐ Mud ☐ Sludge ☐ Debris ☐ Grease
Silt Depth: **0** (in.) Deposits Extent:
Infiltration: **None** Pipe Seal Cond: **Sound**

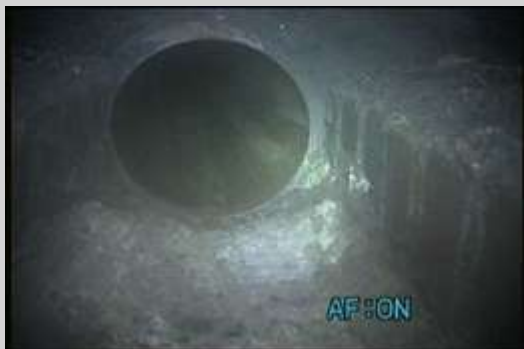
6 O'Clock Inflow

8 in. Circular Gravity Sewer
Pipe In @ 6 O'Clock

Pipe Height: **8.4** (in.) Rod and Bar (Angled)
Pipe Material: **Clay** ☐ Pipe Lined
Invert Depth: **11.26** (ft.) Flow Characteristics: **None**
Deposits: ☒ None ☐ Mud ☐ Sludge ☐ Debris ☐ Grease
Silt Depth: **0** (in.) Deposits Extent:
Infiltration: **None** Pipe Seal Cond: **Sound**
